INDOOR AIR QUALITY ASSESSMENT

**Worcester Fire Department, Engine 15
86 McKeon Road
Worcester, Massachusetts**

Prepared by:
Massachusetts Department of Public Health
Bureau of Environmental Health Assessment
Emergency Response/Indoor Air Quality Program
December 2003

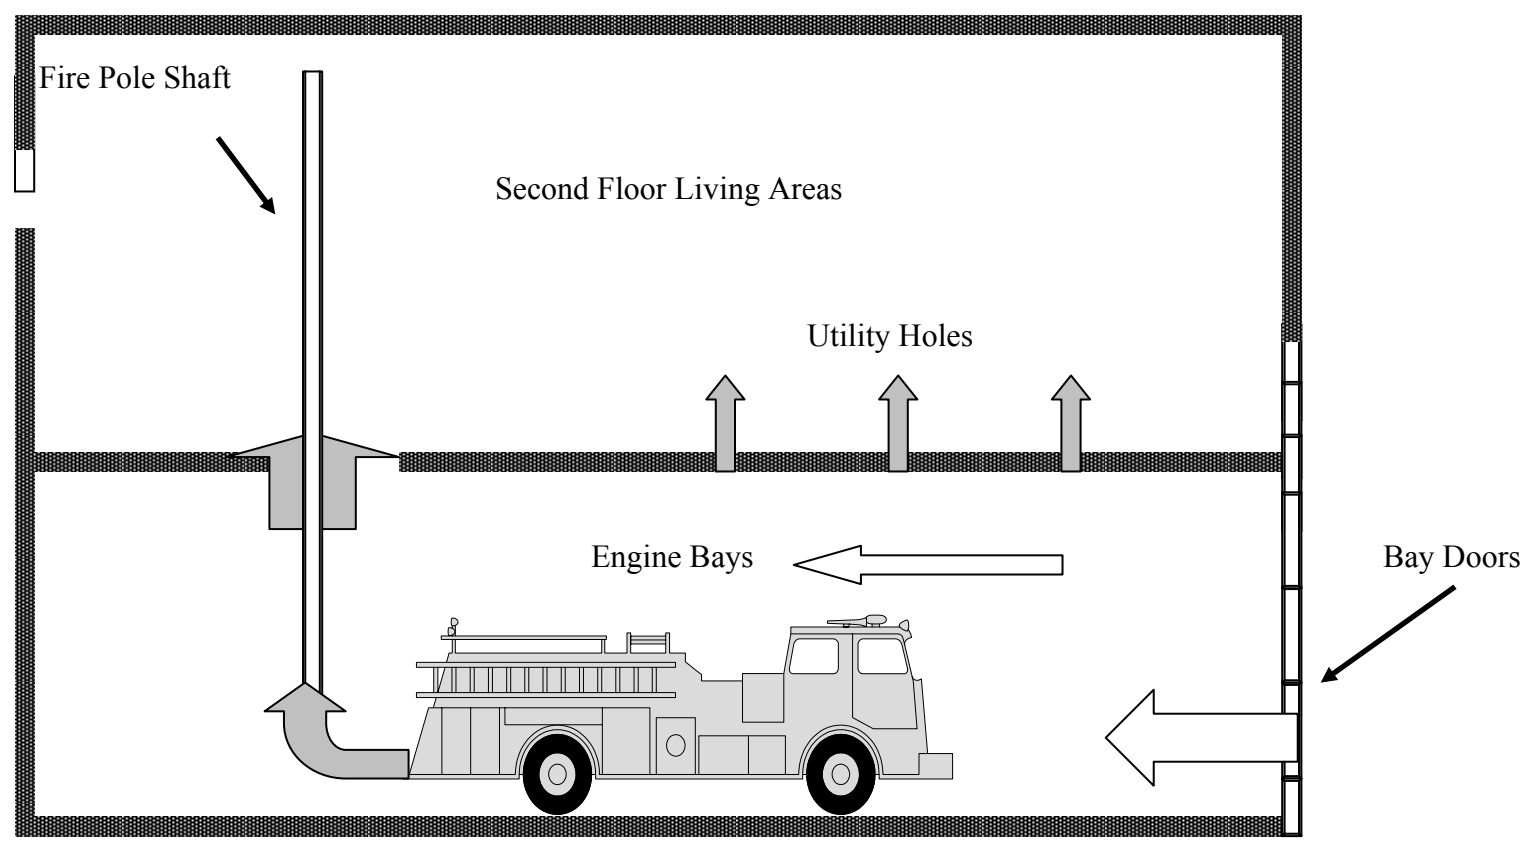
Figure 1 **Potential Pathways of Air and Pollutant Movement from Engine Bays into Occupied Areas***

As mentioned previously, the station is equipped with a mechanical exhaust system to remove exhaust from the engine bay during vehicle idling. The system in use at the station connects directly to the tail pipe of the engine via a pressurized cuff (Picture 9). As the vehicle exits the station, the cuff, which is pulled on a runner, trips a trigger releasing the cuff. The system is designed to collect vehicle exhaust directly at the source and remove it from the building, minimizing exposure. Although the engine bay is equipped with local exhaust ventilation, a number of pathways for vehicle exhaust and other pollutants to move from the engine bay into occupied areas on both the first and second floors were identified (Figure 1).

Another possible pathway for exhaust emissions is through utility holes. The ceiling/walls of the engine bays are penetrated by utility holes. These holes can present potential pathways into occupied areas if they are not airtight. Each of these pathways can allow air to move from the engine bay to occupied areas of the station. In order to explain how engine bay pollutants may be impacting the second floor and adjacent areas, the following concepts concerning heated air and creation of air movement must be understood.

Each of these concepts has influence on the movement of air. As motor vehicles operate indoors, the production of vehicle exhaust in combination with cold air moving from outdoors through open exterior doors into the warmer engine bay can place the bay under positive pressure. Positive pressure within a room will force air and pollutants through spaces around doors, utility pipes and other holes in walls, doors and ceilings. To reduce airflow into the second floor, sealing of these pollutant pathways should be considered.

1. Ensure doors around engine bays fit completely flush with threshold. Seal doors on all sides with foam tape, and/or weather-stripping. Consider installing weather-stripping/door sweeps on both sides of doors with access to the engine bay to provide a dual barrier. Ensure tightness of doors by monitoring for light penetration and drafts around doorframes.

2. Replace/repair clamshell around firepoles to prevent pollutant pathways, consider contacting the manufacturer for replacement parts or for advice on how to prevent airflow around poles.

3. Ensure all utility holes are properly sealed in both the engine bay and their terminus to eliminate pollutant paths of migration.
4. Work with Worcester town officials to develop a preventative maintenance program for all HVAC equipment department wide.

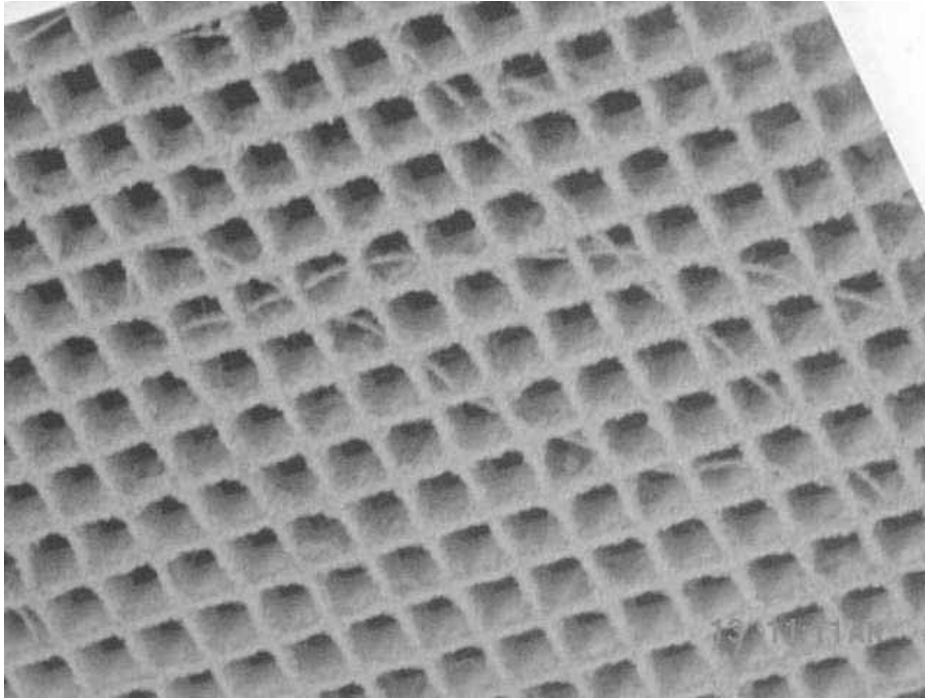
Picture 2

A number of exhaust and return vents in common areas and in restrooms had accumulated dust (Picture 2). If exhaust vents are not functioning, backdrafting can occur, which can re-aerosolize dust particles. In addition, these materials can accumulate on flat surfaces (e.g. desktops, shelving and carpets) in occupied areas and subsequently be re-aerosolized, causing further irritation.

Ceiling-Mounted Return Vent, Note Dust and Cobweb Accumulation on Vent

11. Make repairs to windows to eliminate spaces around frames.
12. Clean exhaust and return vents periodically to avoid the build-up of excessive dust.
13. It is highly recommended that the principles of integrated pest management (IPM) be used to rid the building of pest. A copy of the IPM recommendations can be obtained from the Massachusetts Department of Food and Agriculture (MDFA) website at the following website:

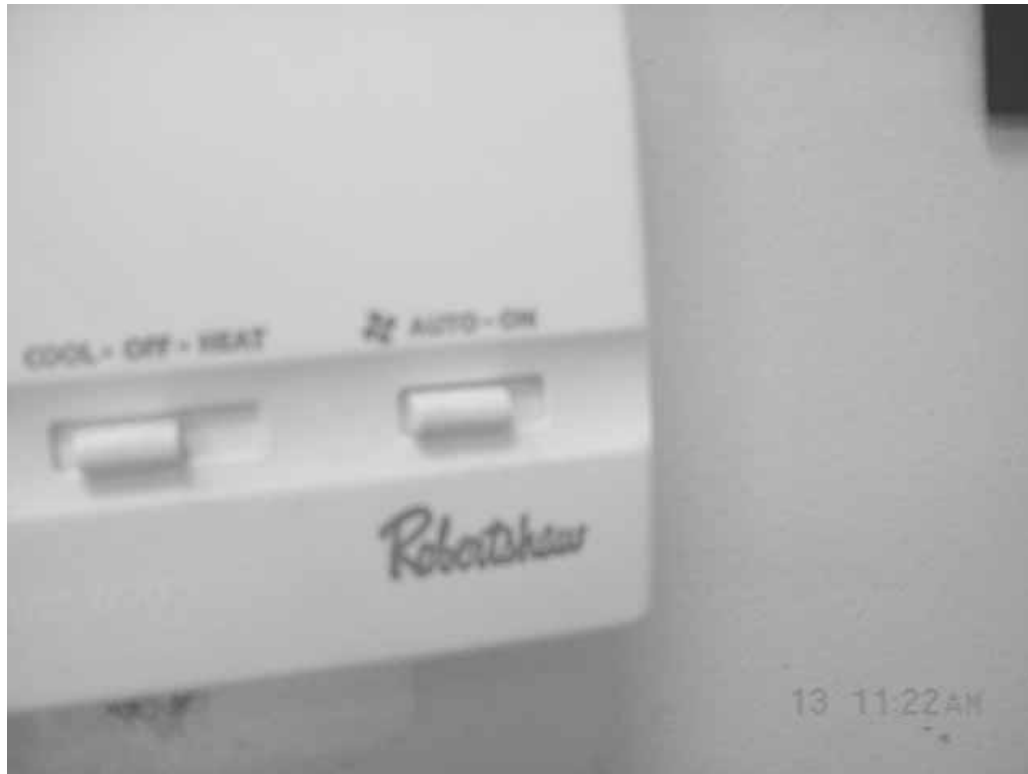
Picture 3

Thermostats have fan settings of “on” and “auto” (Picture 3). All controls were set to the “auto” setting during the assessment. The automatic setting activates the HVAC system at a preset temperature. Once the thermostat reaches a preset temperature, the HVAC system is deactivated until the temperature drops below the heating set point. Therefore, no mechanical ventilation is provided until the thermostat re-activates the system.

Fan Setting on Right in “Auto” Position

6. Continue with plans to transfer local control of HVAC system to WFD staff, ensure staff are properly trained to control the system.
7. To maximize air exchange, the BEHA recommends that both supply and exhaust ventilation operate continuously during periods of building occupancy independent of

thermostat control (excluding engine bay exhaust system). Consider setting thermostat controls to the fan “on” position to provide constant supply and exhaust ventilation.

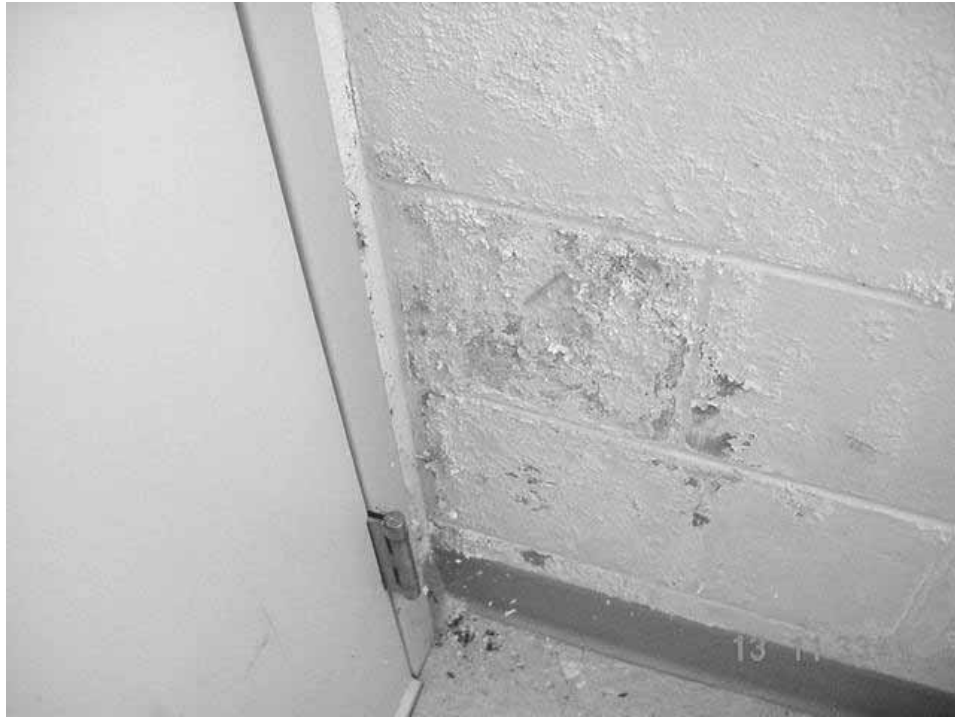
Picture 4

The building has reportedly experienced problems with water penetration, most notably on the east side of the building. Along the wall of the engine bay and on the second floor in the day room, water leaks were evidenced by damaged plaster on walls, stained ceiling tiles, peeling paint and efflorescence (Pictures 4 & 5). Water-damaged ceiling tiles can provide a source of mold and should be replaced after a water leak is discovered and repaired. Efflorescence is a characteristic sign of water damage to building materials such as brick or plaster, but it is not

mold growth. As moisture penetrates and works its way through mortar around brick, water-soluble compounds dissolve, creating a solution. As the solution moves to the surface of the brick or mortar, water evaporates, leaving behind white, powdery mineral deposits. This condition indicates that water from the exterior has penetrated into the building. In this case the most likely source of water penetration is from improper drainage along the roof where the engine bay meets the hose drying room, allowing water to seep down the side of the building (Pictures 6 & 7).

Water Damage, Peeling Paint and Efflorescence

10. Install gutters/downspouts to the junction where the engine bay meets the hose drying room to direct water away from the building. Once repaired, replace any remaining water damaged building materials. Examine the area above and behind these areas for microbial growth. Disinfect areas of water leaks with an appropriate antimicrobial as necessary.

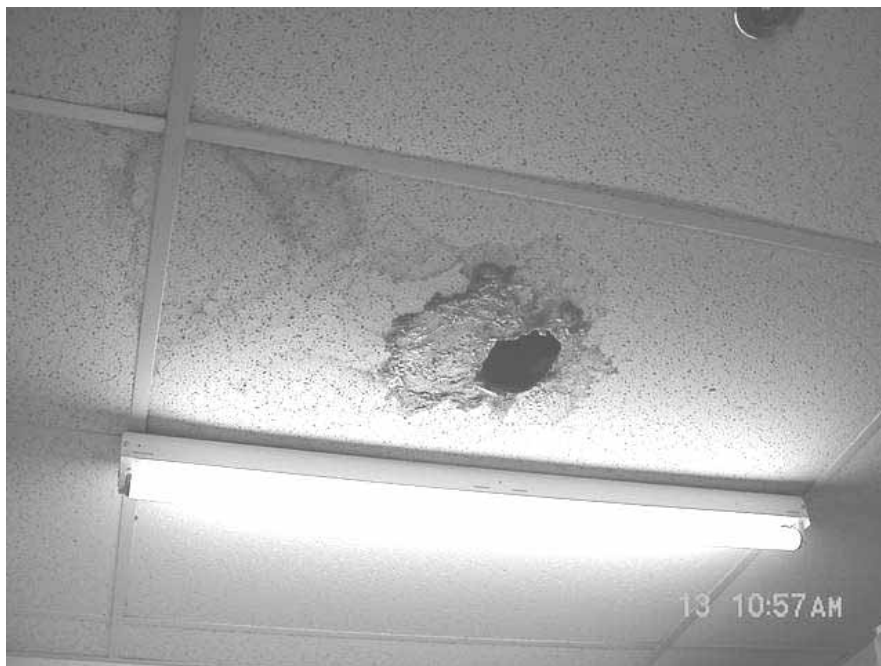
Picture 5

Water Damaged Ceiling Tiles

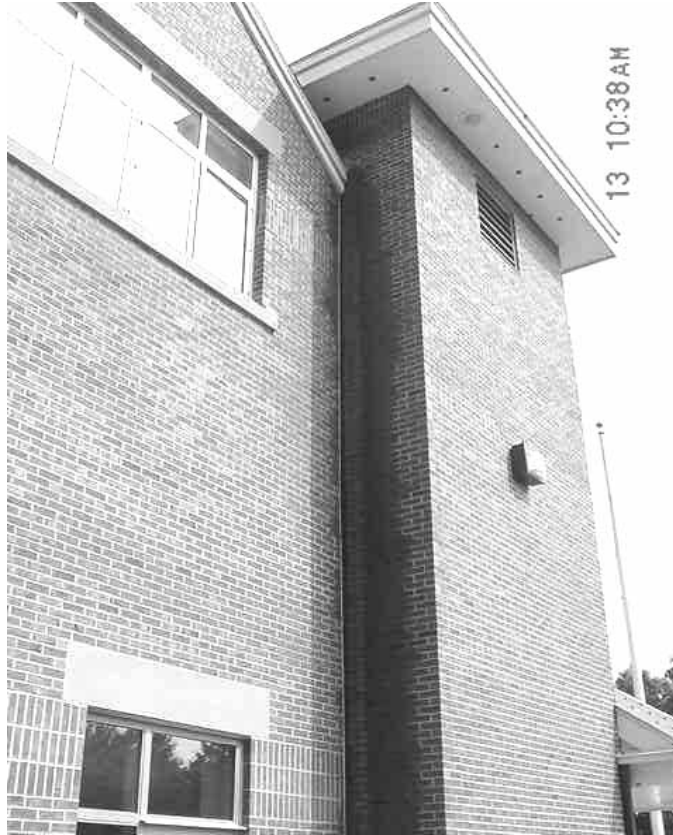
Picture 6

**Junction/Seam between the Engine Bay and Hose Drying Room Note Dark Stain
at Seam Indicating Water Damage**

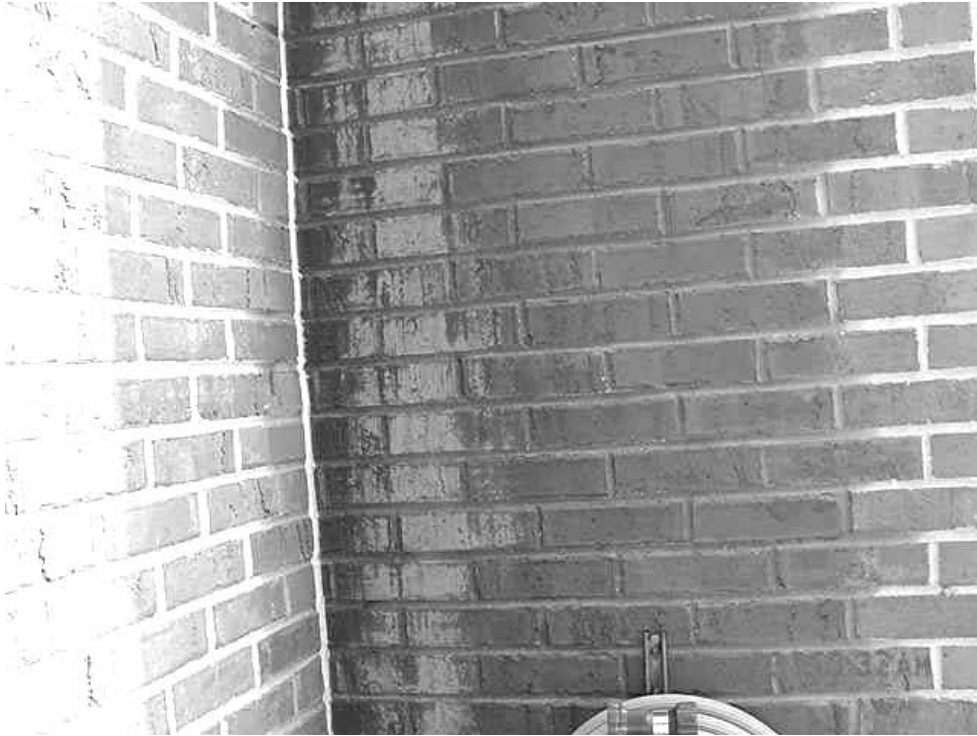
Picture 7

Close-up of Water Damage Shown in Preceding Picture Light Stains Indicate Moss Growth

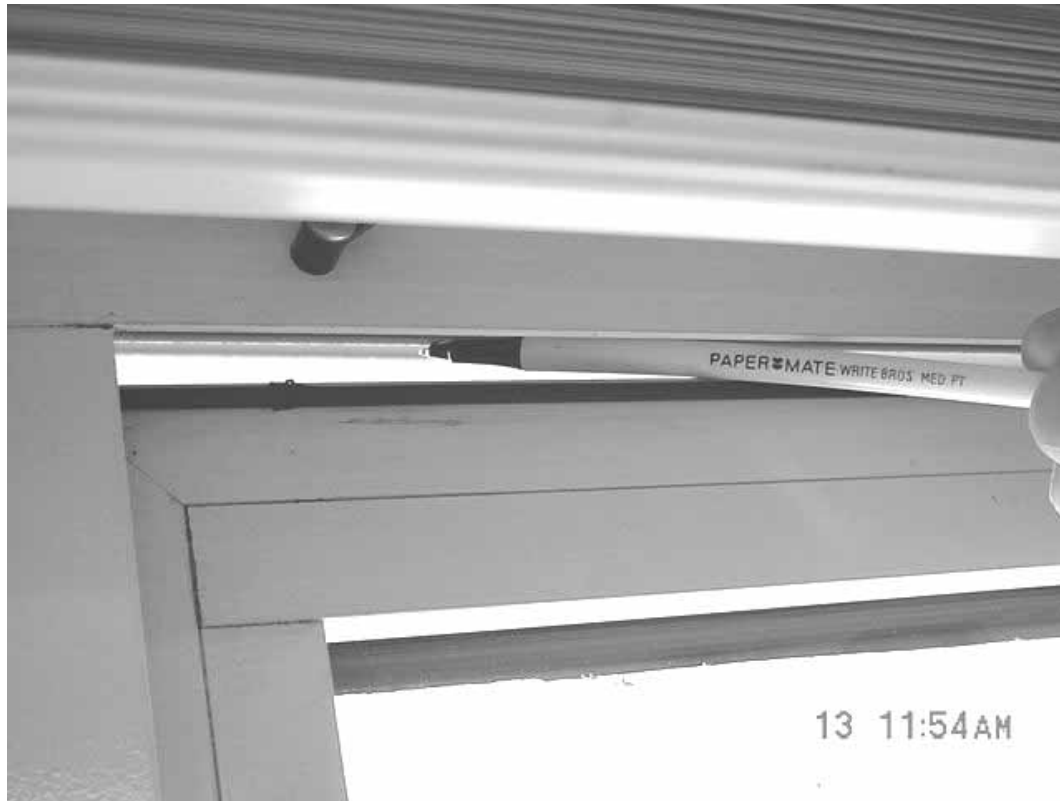
Picture 8

Another means for water penetration into the building was around window frames. Spaces were observed between windows and window frames (Picture 8). Repeated water damage to porous building materials (e.g. wallboard, ceiling tiles, carpeting) can result in microbial growth. The US Environmental Protection Agency and the American Conference of Governmental Industrial Hygienists (ACGIH) recommends that porous materials be dried with fans and heating within 24-48 hours of becoming wet (US EPA, 2001; ACGIH, 1989). If not dried within this time frame, mold growth may occur. Once mold has colonized porous materials, they are difficult to clean and should be removed.

Spaces around Window Frames on Second Floor, Pen Inserted to Show Width

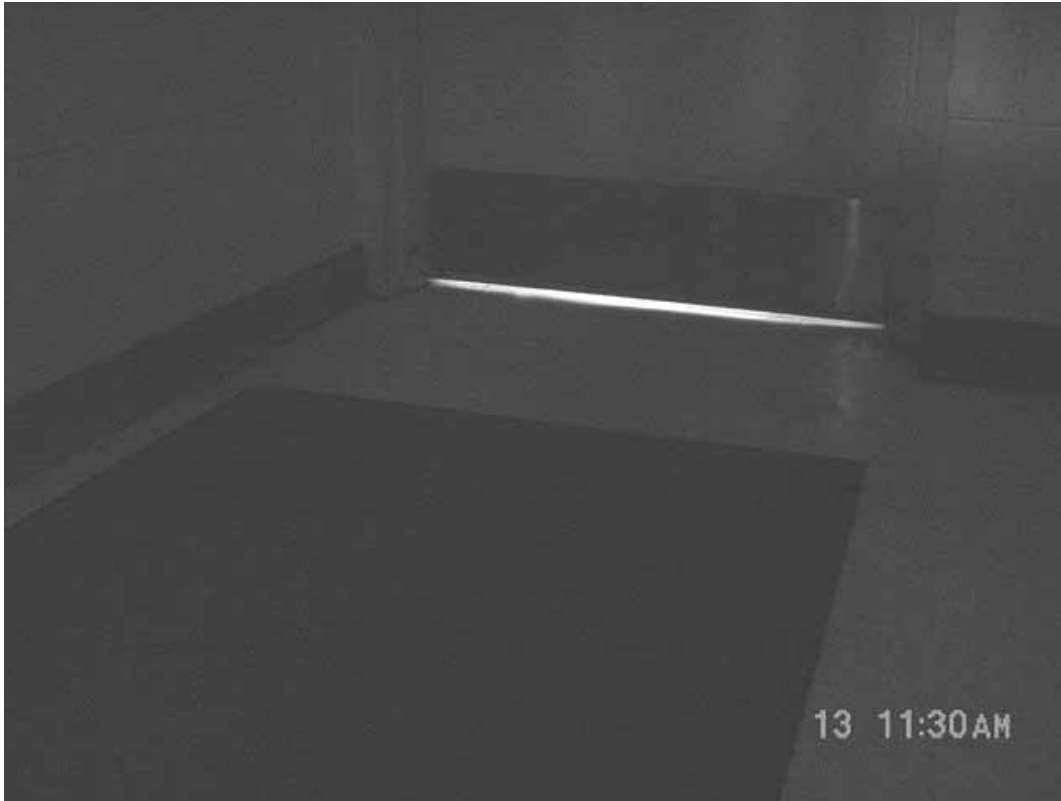
Picture 10

The door to the stairwell (off the engine bay) leading to the upstairs had spaces beneath the door and light could be seen penetrating into the stairwell through this space (Picture 10). Picture 11 shows spaces around the firepole clamshell indicating it does not close tightly.

Light Penetrating beneath Engine Bay Door

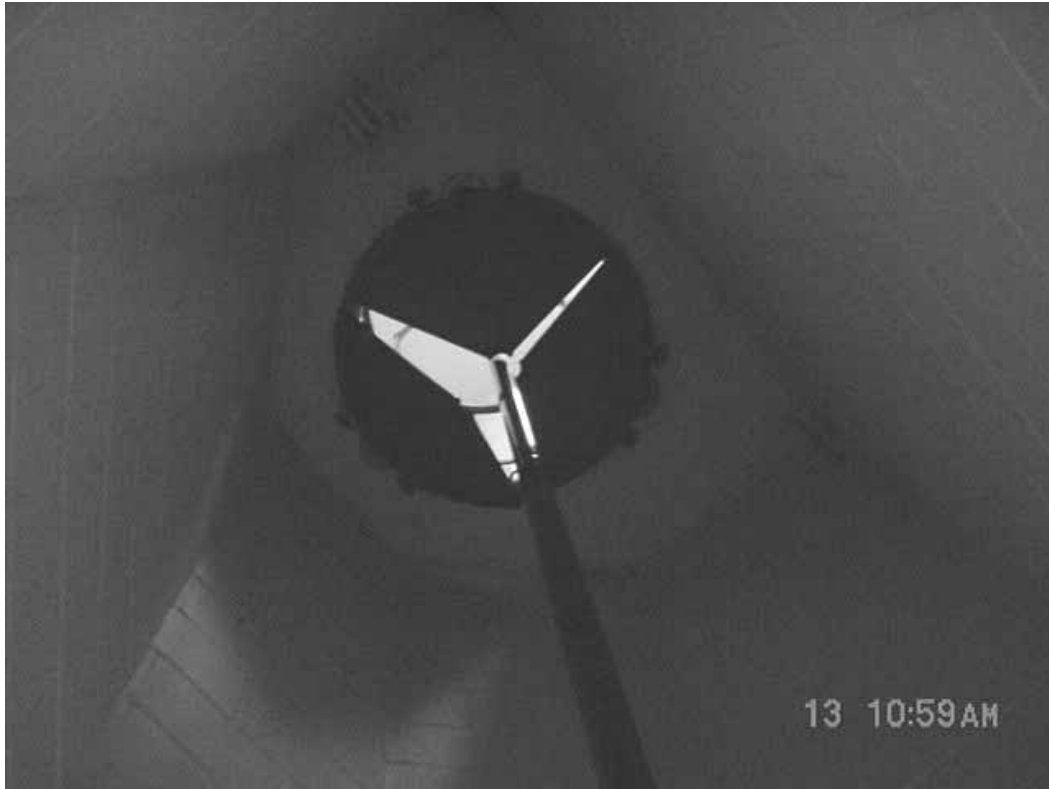
Picture 11

Light Penetrating around Fire Pole Clamshell

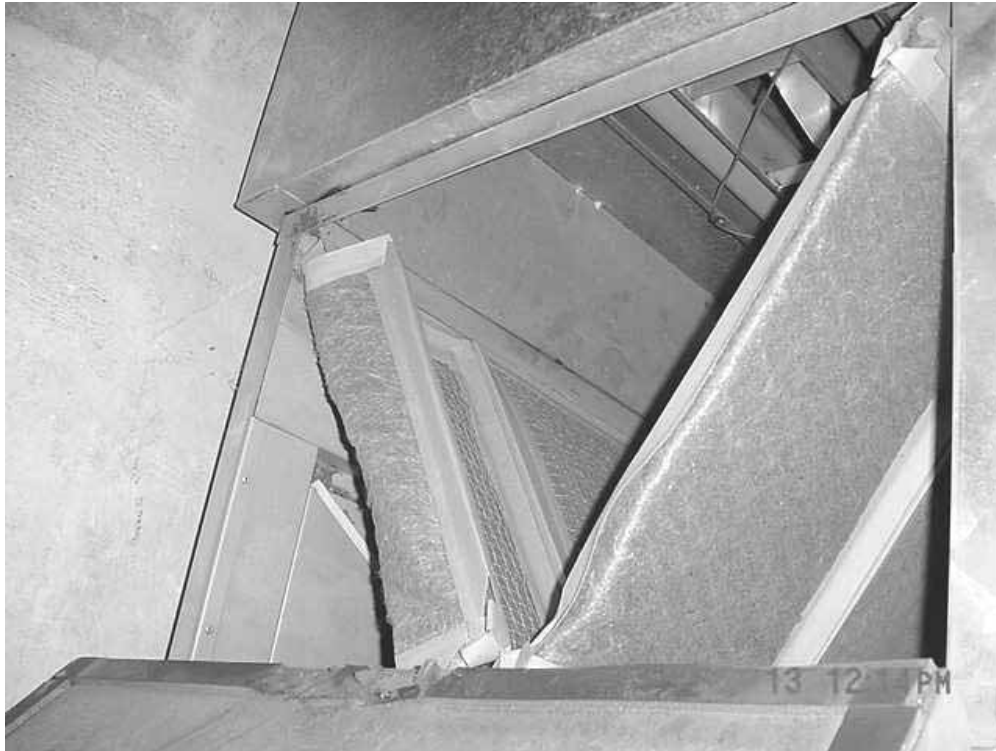
Picture 12

WFD staff could not identify the last filter change or preventative maintenance done on the HVAC equipment. BEHA staff inspected AHU filters. The attic AHU filters were bent to fit into their racks (Picture 12). The watch room unit did not have filters installed. In order to decrease aerosolized particulates, properly fitting, disposable filters should be installed in AHUs. The dust spot efficiency is the ability of a filter to remove particulates of a certain diameter from air passing through the filter. Filters that have been determined by ASHRAE to meet its standard for a dust spot efficiency of a minimum of 40 percent would be sufficient to reduce airborne particulates (Thornburg, D., 2000; MEHRC, 1997; ASHRAE, 1992). Note that increased filtration can reduce airflow produced by the univent through increased resistance (called pressure drop). Prior to any increase in filtration, AHUs should be evaluated by a ventilation engineer to ascertain whether they can maintain function with more efficient filters.

Attic AHU Filters Bent to Fit in Unit

5. Change filters for HVAC equipment as per the manufacturer's instructions or more frequently if needed. Ensure filters fit flush in their racks to prevent filter bypass.

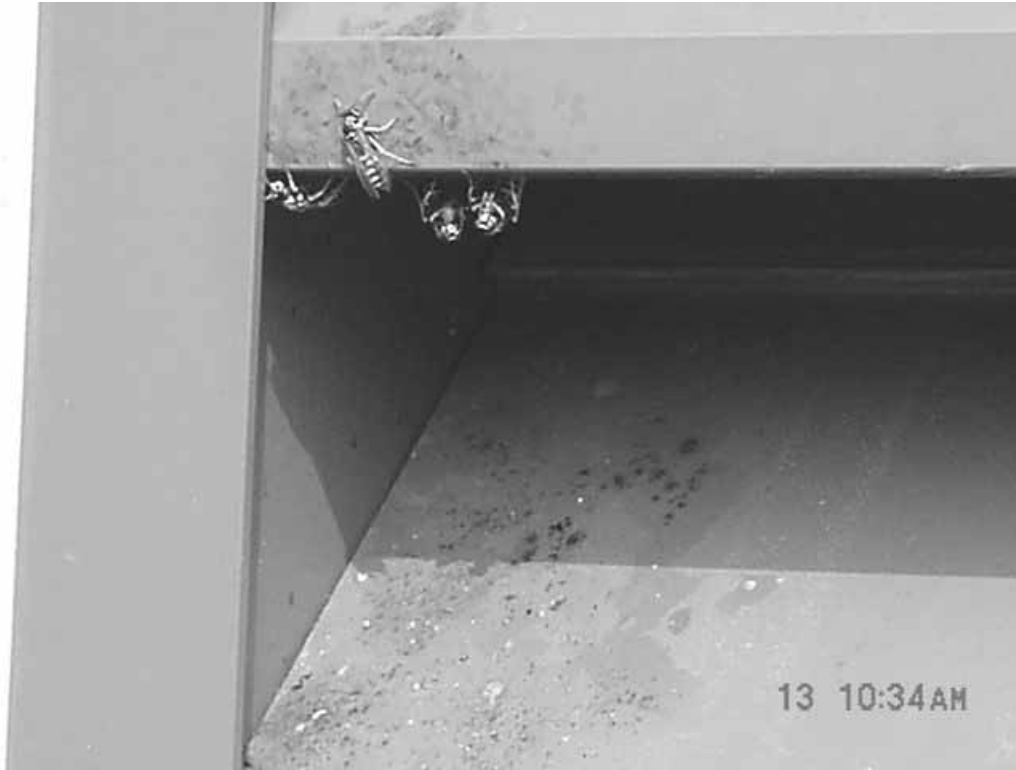
Picture 13

Finally, during a perimeter inspection of the building, BEHA staff observed several bees/wasps nests on the exterior of the building and an infestation of bees inside the vent for the hose drying room (Pictures 13 & 14). Dead cockroaches were observed in the stairwell and in the gasket to the refrigerator in the kitchen. Under current Massachusetts law (effective November 1, 2001) the principles of integrated pest management (IPM) must be used to remove pests in state buildings (Mass Act, 2000). Pesticide use indoors can introduce chemicals into the indoor environment that can be sources of eye, nose and throat irritation. The

Bee/Wasp Infestation in Vent to the Hose Drying Room

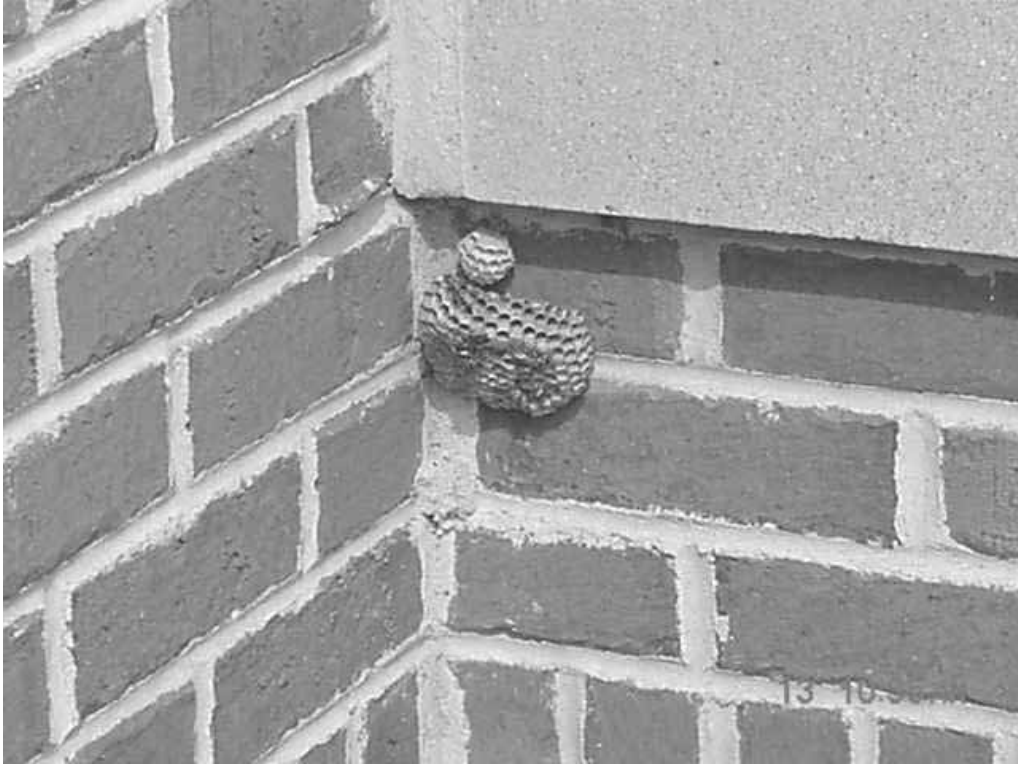
Picture 14

Bee/Wasp's Nests on Exterior of the Building
